Non-invasive diagnostic methods for investigating the quality of Žilina airport's runway

Abstract: The Žilina airport was after almost 50 years of use measured by non-invasive methods including GPR and Profilograph GE in order to investigate the quality of the runway pavement at the chosen spots. Since it was just a pilot action, a sample of survey was carried out. The testing spots were placed where the geologic drill core J02 have been drilled out. The measurements performed by Profilograph GE were used to verify the quality of the pavement surface in term longitudinal unevenness by means of index IRI and C. The GPR survey was performed in 3D geometry, hence in the x - and y -direction. A horn type antenna with central frequency of 2 GHz was used on the test field in order to verify the thicknesses of pavement construction layers. Here, the result of a 3D survey is presented. The investigation confirms two sub-horizontal construction layers of the runway pavement. In some areas the GPR interpretation was not possible due to the signal attenuation. This significant signal attenuation is found mainly in the areas where the linear cracks are situated.

Key words: runway, pavement s

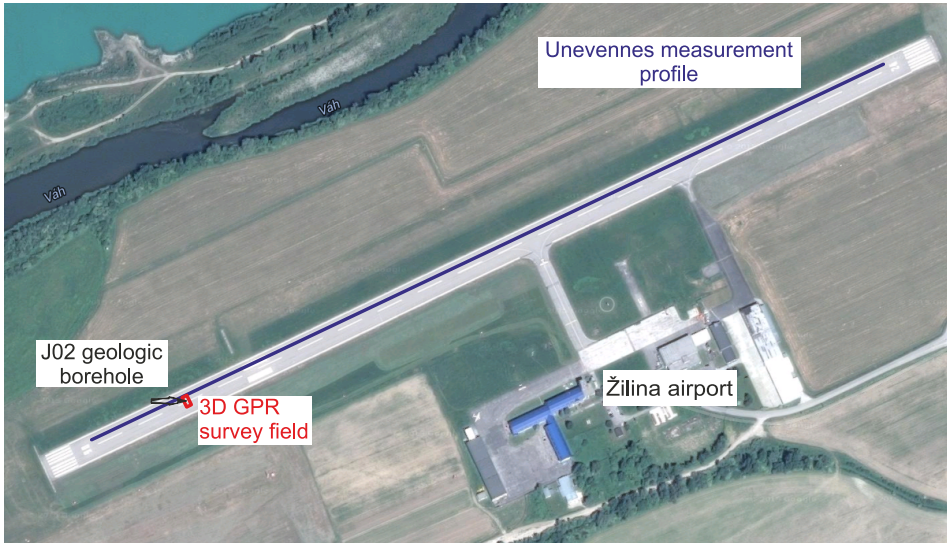
Fig. 1. Satellite map of the Žilina International Airport with the schematic position of the Profilograph GE and GPR measurements.

Žilina airport at Dolný Hričov was built in the 1970s to replace the formerly Brazovský Majer Airport that had given ground to the developing Žilina city. Due to planned reconstruction, a diagnostic was done by non-invasive diagnostic methods. Since the runway covers a relatively large area, a few test fields were chosen to carry out the investigation (Fig. 1).

such as drill cores. On the other hand the accuracy of the geophysical methods increases if more than one geophysical investigation approach is used. In this particular case, a geologic drill core was available (Fig. 1) which allows accurate identification of the pavement construction layers (Fig. 9) with the geophysical ones.

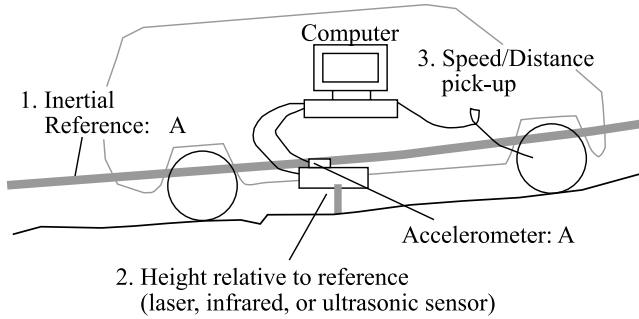
algorithm) to the acceleration with respect to the reference plane (Inertial Reference) defined by the instantaneous position of the accelerometer in the vehicle (Fig. 2). The height of the road surface relative to the refer-

Fig. 2. The principle of creating a reference line for measuring the evenness of roads (Sayers and Karamihas, 1988).

ence plane is thus the distance between the accelerometer in a vehicle and the road surface below it (Fig. 2). This height is measured by contactless sensors which in this case are laser scanners.

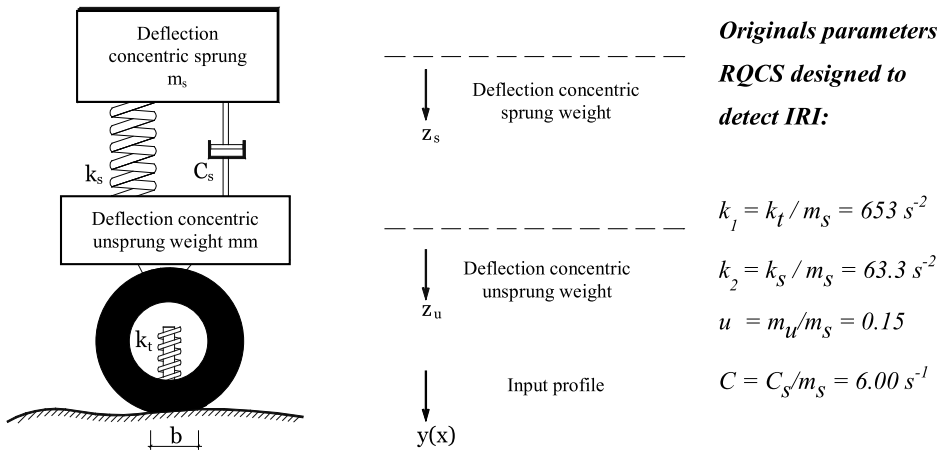
Currently, the world’s most used parameter to evaluate the quality of pavement surface in term of longitudinal unevenness is the International Roughness Index – IRI. This parameter is obtained by using a mathematical simulation of driving a reference quarter-car model (Fig. 3, Sayers et al., 1986; Gillespie, 1992; Molenaar, 1992) along measured surface irregularities. TP 4/2012 is valid for the evaluation of unevenness of road pavements in Slovakia (Decký et al., 2012). In accordance with the global trends in the diagnostics of pavement unevenness the fourth vehicle model is greatly used, commonly known as the “Reference Quarter-Car Simulation” (RQCS – reference model-quarters of passenger vehicles). The RQCS model (Fig. 3) can be mathematically described by two second order differential equations:

- m_s, m_u – the weight of sprung mass and unsprung mass [kg],
- k_s, k_t – spring constants of springs and tires [N m^{-1}],
- C_s – linear damping coefficient shock absorber [Ns m^{-1}],
- z_s, z_u – vertical displacement of the sprung and unsprung masses [m],
- $\dot{z} = z(1) = dz_s/dt$ – the vertical velocity of the sprung mass [m s^{-1}],
- $\ddot{z} = z(2) = d^2z_s/dt^2$ – vertical acceleration of the sprung mass [m s^{-2}],
- $\dot{z}_u = z(3) = dz_u/dt$ – vertical velocity of the unsprung mass [m s^{-1}],
- $\ddot{z}_u = z(4) = d^2z_u/dt^2$ – vertical acceleration of the unsprung mass [m s^{-2}],
- $y(t)$ – input profile elevation road bumps [m].

Fig. 3. The reference quarter-car model to estimate the index IRI.

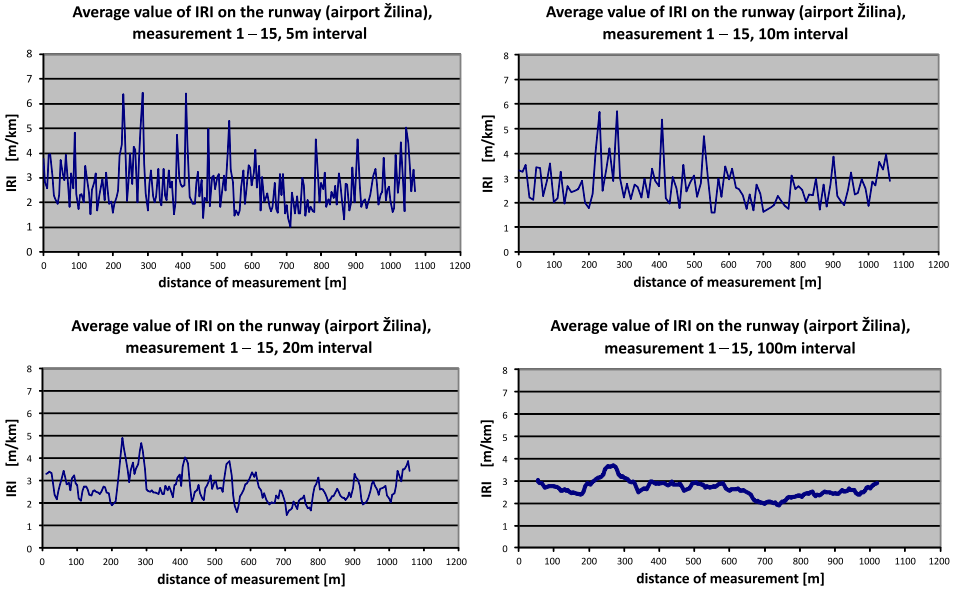
Based on the measurements of the longitudinal unevenness of airport's runway, situated in the cadastral area of Dolný Hričov, the results were based on 15 measurements carried out on this runway. Due to the wide range of data, the presented data are averaged values of the evaluations in 5, 10, 20 and 100 m evaluating intervals (Fig. 4).

Fig. 4. Evaluation of the airport runway pavement surface in term of longitudinal unevenness using IRI, 15 – times of measurements.

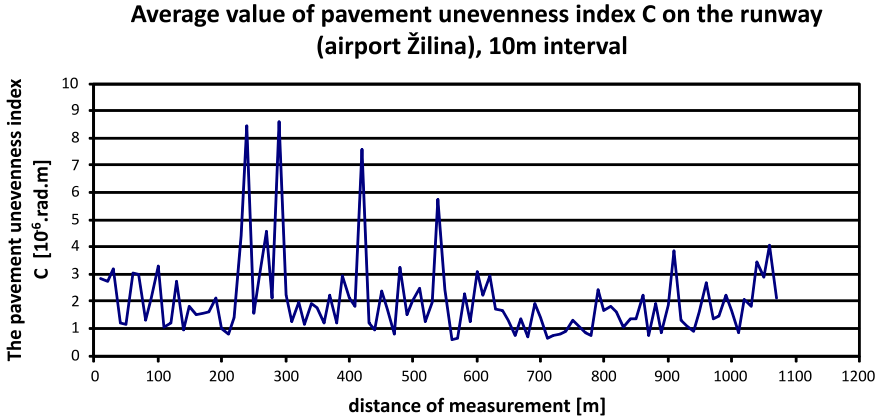
The pavement unevenness index C has been drawn in Fig. 5 on the basis of formula (4) and the above-mentioned evaluation value intervals:

Fig. 5. Evaluation of the airport runway unevenness according to pavement unevenness index C , 10 m interval.

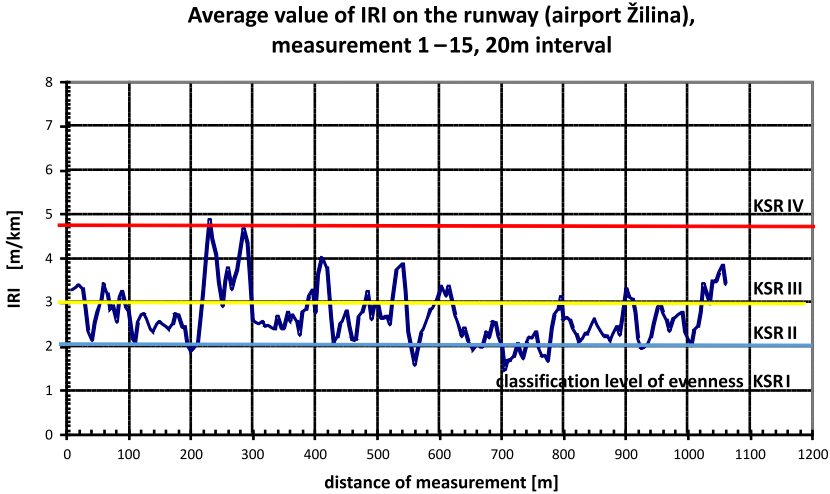
In the case of unevenness evaluation by means of the evaluation parameter IRI methodology TP 4/2012 was applied. According to it the values for the 20 m interval evaluation are crucial (Fig. 6).

Fig. 6. Evaluation of longitudinal unevenness of the airport runway surface using IRI. Thresholds indicating the classification level of evenness (KSR) according to TP 4/2012 by Table 2.

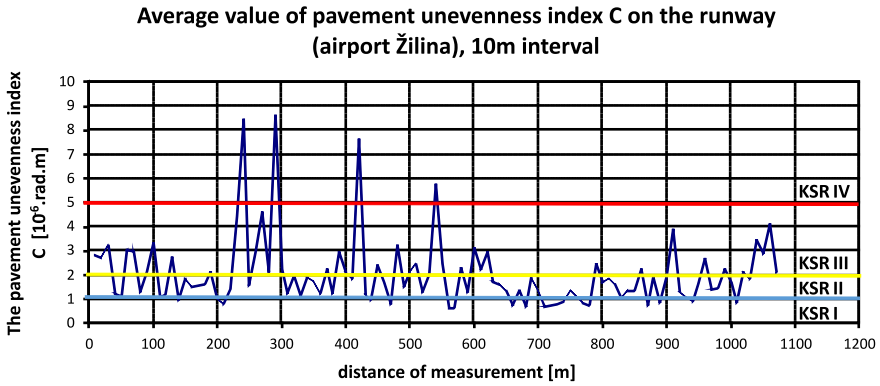
On the basis of the realized measurements and evaluation of the pavement surface’s longitudinal unevenness of the airport runway at Dolný Hričov (Žilina airport) (Fig. 7 and Fig. 8) we can say that the pavement is considered low quality but sufficient to remain in use as a runway.

Fig. 7. Evaluation of longitudinal unevenness of the airport runway in terms of construction and technical state via pavement unevenness index C indicating the classification level of evenness (KSR) according to Table 3.

The results and evaluation of longitudinal unevenness measurements and outputs of GPR measurements point to the fact that the airport's runway pavement is suitable for use by traffic. Although, the airport has been in use since the mid-70s, construction and the sub-base layers of the runway pavement are not significantly disturbed according to the survey results. On the other hand the eventual reconstruction would be useful in terms of comfort and safety of use.

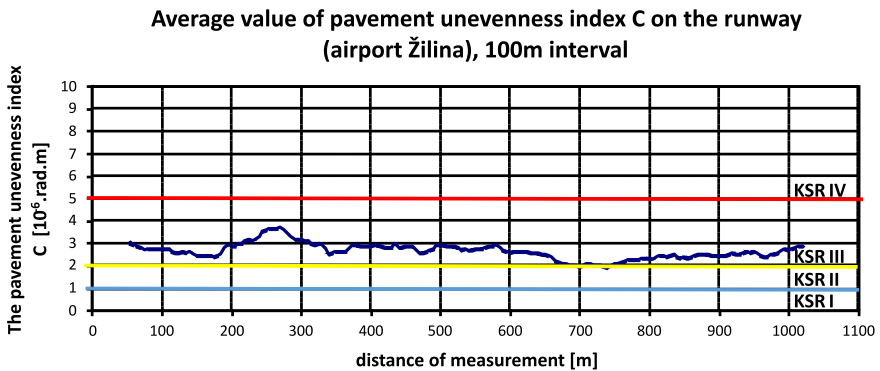
Fig. 8. Evaluation of longitudinal unevenness of the airport runway in terms of comfort and driving safety via pavement unevenness index C indicating the classification level of evenness (KSR) according to Table 3.

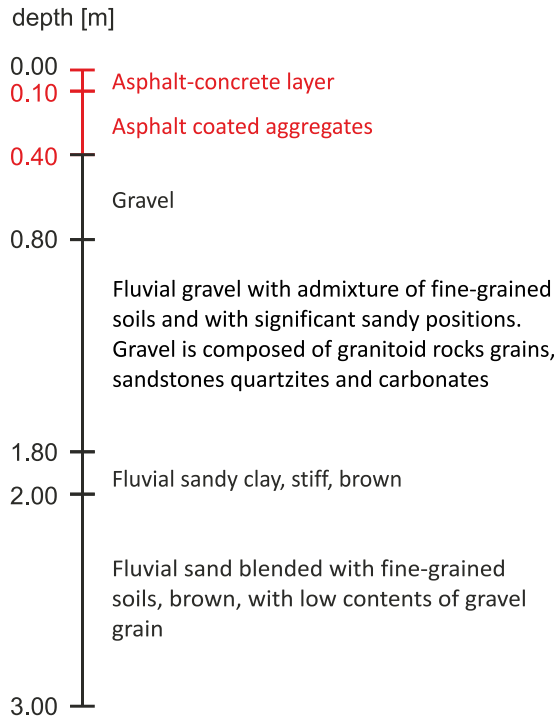
Geological drill core J02 – schematic description

Fig. 9. Schematic description of the J02 geological drill core. For the purpose of the 3D GPR survey, the depth of the first and second boundaries (red font) was taken into account in order to determine the dielectric constant value.

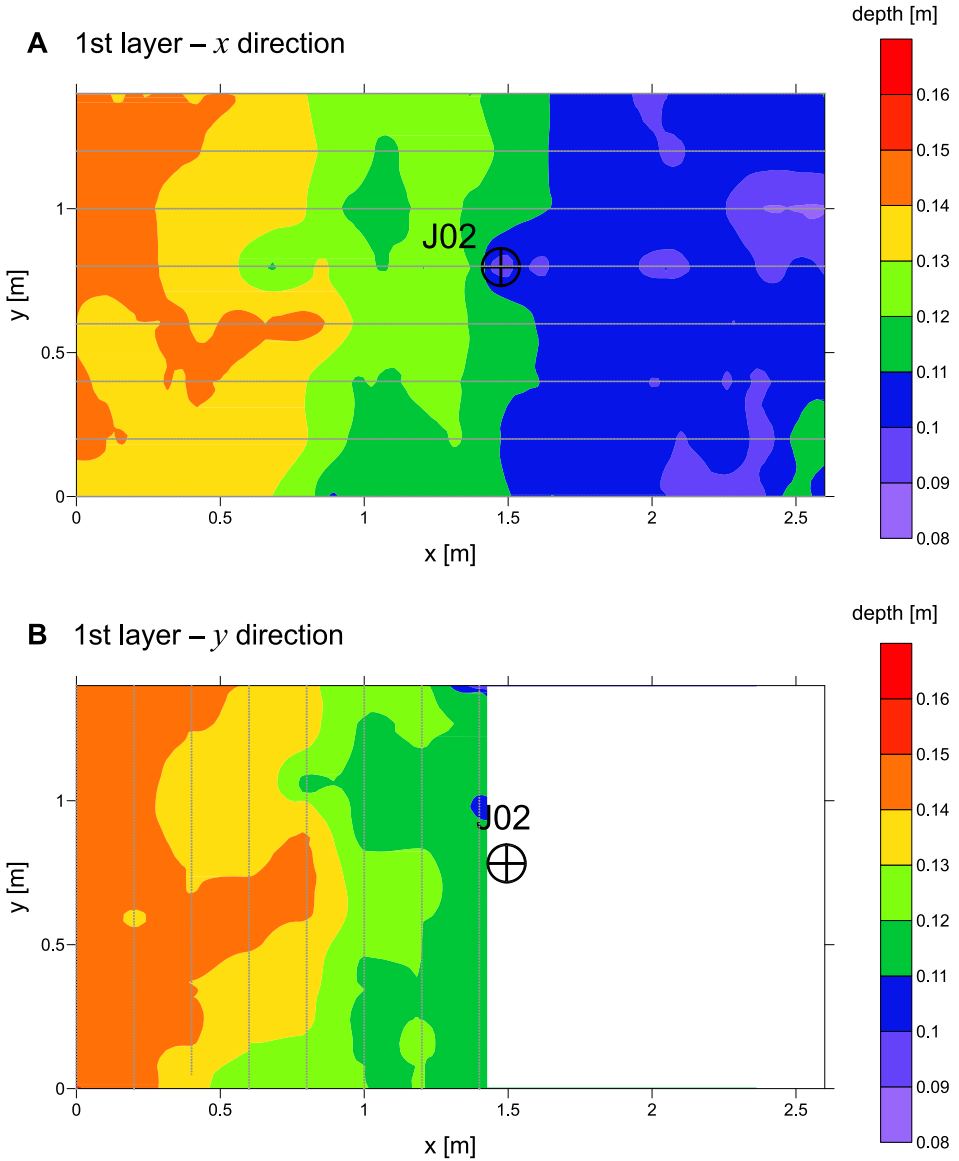
The first layer shown in (Fig. 10) based on the drill core comparison was identified as an asphalt-concrete layer. The result in the x -direction shows very good quality and almost on every single profile the course of the first layer can be tracked. On the other hand only the first half of the y -direction profiles can be well tracked. Here, if there was no possibility to distinguish any sharp boundary between the layers, the radargram stays un-interpreted (blank). The GPR interpretation error could be about 10–15% (Maser and Scullion, 1991; Morey, 1998; Matula, 2013), due to a non-unique dielectric constant value. In reality, the studied environment is not perfectly homogeneous, therefore the dielectric value may vary. Also, the electro-magnetic nature of the geological or anthropogenic environment that should have the same characteristics may vary in some intervals. Dielectric constant used in this survey was set based on the calibration with the geologic drill core J02, (Fig. 9) (Záthurecký et al., 2007). The dielectric constant value of 4 for the first Asphalt-concrete layer was used.

Fig. 10. **A.** The resulting contour map of the first identified layer in the x -direction. **B.** The resulting contour map of the first identified layer in the y -direction. Blank fields show areas where no data are available based on the interpretation. Grey lines show interpreted GPR profiles. Black cross in circle shows place where the J02 drill core was placed.

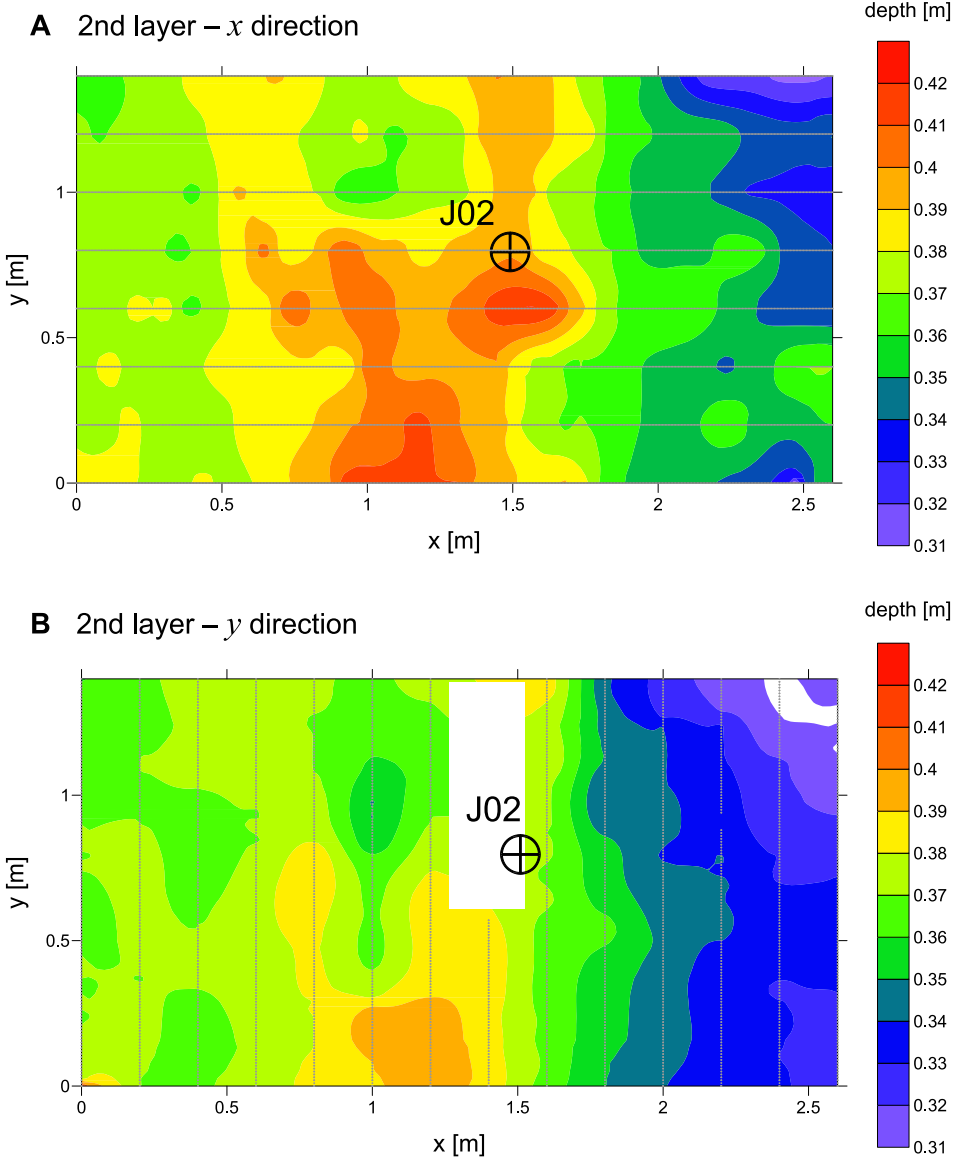
The second layer shown in the (Fig. 11) based on the drill core was identified as asphalt coated aggregates. In both directions, the layer was tracked following the obvious boundary. Comparing results obtained from both directions, some differences can be seen. However, these differences are not quantitatively significant; they are within the standard error of interpretation, the central part of the contour maps report mismatch. The result in x -direction shows very good quality, the second layer can be well tracked on every GPR profile. The y -direction profiles can also be well tracked, except in the second half of the eighth profile ($x = 1.4$ m) where the interpretation is missing. If there was no possibility to distinguish any sharp boundary among the layers, the radargram stays un-interpreted (blank) as it was in the previous discussed case. The dielectric constant value of 4.6 for the second asphalt coated aggregates layer was used. The dielectric constant value was determined based on the geologic drill core, as it was for the first layer.

Fig. 11. **A.** The resulting contour map of the second identified layer in the x -direction. **B.** The resulting surface of the second identified layer in the y -direction. Blank fields show areas where no data are available based on the interpretation. Grey lines show interpreted GPR profiles. Black cross in circle shows place where the J02 drill core was placed.
