Indoor radon monitoring in Zázrivá

Abstract: Indoor radon survey in Zázrivá was conducted within the framework of the project “Multidisciplinary research of geophysical and structural parameters, and environmental impacts of faults of the Western Carpathians”. Monitoring was carried out in selected houses and kindergarten using RamaRn detectors. Annual average of indoor radon varied between 45 and 260 Bq/m³, with median of 90 Bq/m³. Seasonal variation with minimum in summer was observed in the majority of monitored rooms. Radon concentration higher than 200 Bq/m³ was measured only in rooms with direct contact with the subsoil. A possible relation between the position of a monitored building close to an assumed fault line and elevated indoor radon levels was not proven.

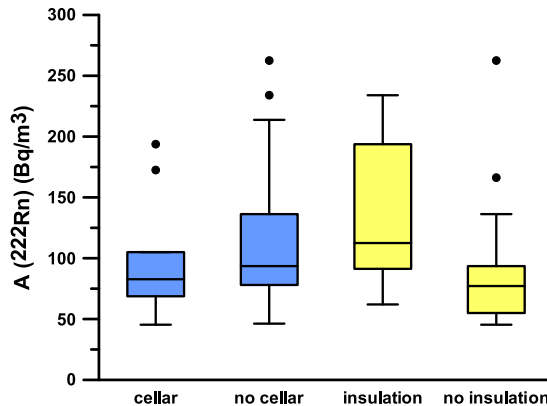
The results were examined in the respect of presence or absence of a cellar underneath the room and thermal retrofit of the building (Fig. 5) using the notch-box plots. Almost 34% of the monitored rooms in Zázrivá were situated above a cellar. RAC tends to be lower in these rooms, because the cellar usually protects the ground floor rooms from the direct soil airflow (Papaeftymiou *et al.*, 2003; Borgoni *et al.*, 2014; Müllerová *et al.* 2016). However, unless they are well insulated, cellars may sometimes serve as an entry point for radon into a building (Buchli and Burkart, 1989). Although RAC higher than 200 Bq/m^3 was found only in the rooms with direct contact with the subsoil, the graph shows that 95% confidence intervals of medians in no cellar and cellar groups overlap and therefore medians are considered the same within the confidence level.

Fig. 5. The comparison of indoor ^{222}Rn concentration according to the presence/absence of cellar and thermal insulation.

Thermal retrofit works, such as window replacement and thermal insulation usually resulted in an increase of indoor RAC, due to reduction of air exchange rate of the house (Collignan *et al.*, 2016). In Zázrivá, the distribution of indoor RAC between rooms in houses with and without thermal insulation shows that higher indoor values were found in thermally insulated buildings.

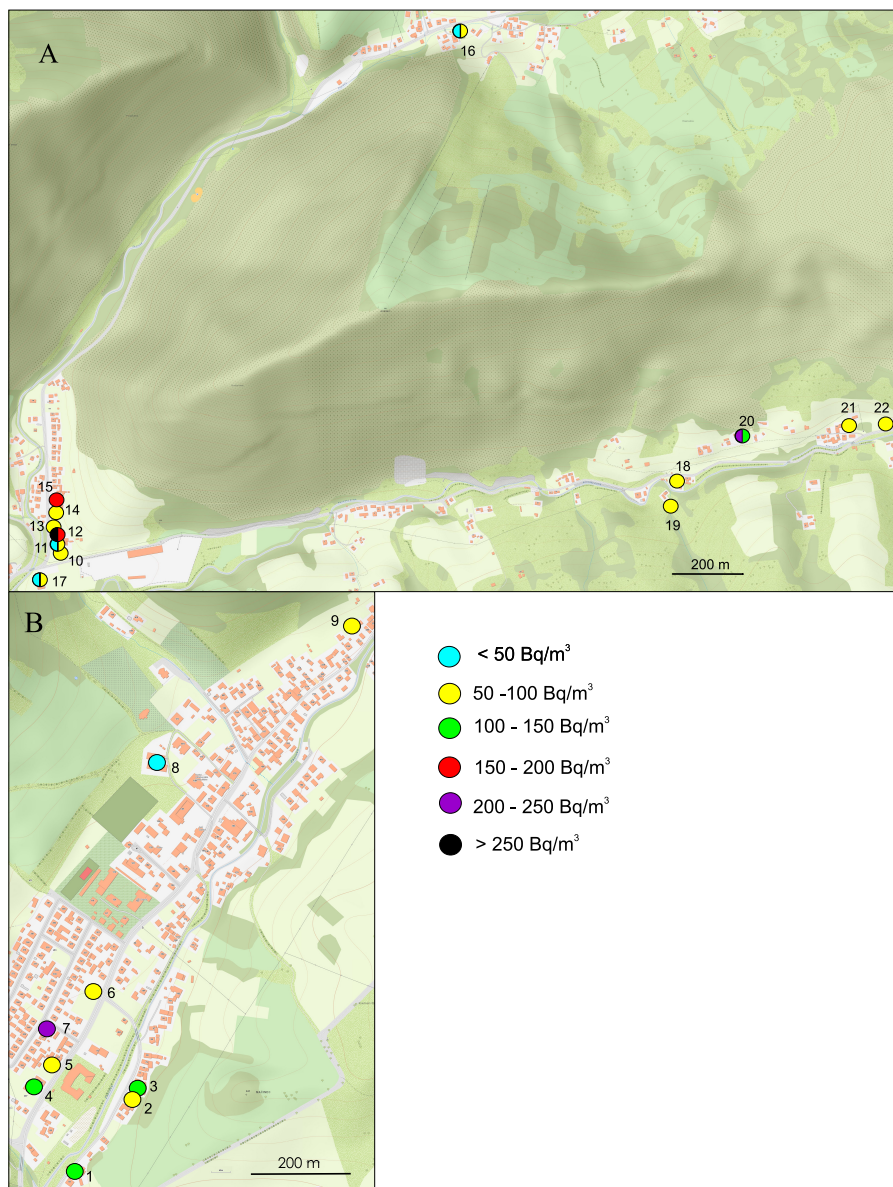
Spatial distribution of the results of indoor RAC survey is depicted on Fig. 6. A visual comparison with radon risk map (Fig. 2B) did not reveal significantly elevated RAC in buildings situated in Kozinská part of Zázrivá. Although the highest indoor radon level (480 ± 60) Bq/m^3 was measured in the summer monitoring period, in house 20 in this part of Zázrivá, according to the questionnaire, this house was poorly ventilated, which probably caused an elevated indoor RAC, which was later not observed in other monitoring periods. Monitored house was relatively new, constructed in 2012 from a combination of wood and aerated concrete and has no cellar under the monitored rooms. Indoor RAC measured in other houses in Kozinská were similar to radon levels found in Havrania (Fig. 6A) and Central part of Zázrivá (Fig. 6B), which are situated in medium radon risk areas. A large part of Havrania is also situated in a high radon risk area, unfortunately most houses here were not permanently inhabited or measurements were not allowed by their owners, therefore indoor RAC was investigated solely in house 16. This house was built in 1940 from wood and did not underwent any kind of thermal retrofit, which may result in annual average of RAC less than 50 Bq/m^3 in both monitored rooms.

Fig. 6. Spatial distribution of annual average of indoor RAC in 22 monitored buildings in Kozinská and Havrania (A) and central part of Zázrivá (B) (modified according to *ZBGIS Mapa*, <https://zbgis.skgeodesy.sk>).

The highest annual average of indoor RAC among monitored houses was determined in a room of house 12 in Havrania part. It was constructed in 1980 from aerated concrete. Both monitored rooms were situated in a direct contact with the subsoil and indoor RAC exceeded 200 Bq/m^3 also in the second investigated room. This house was not thermally insulated.

Annual value of indoor RAC exceeding 200 Bq/m^3 was also found in both monitored rooms in house 7 situated in the Central part (Fig. 6B). This house was built in 1984 from aerated concrete, has no cellar and according to the questionnaire it was intensively ventilated.

In both classrooms of the kindergarten (No. 9) indoor RAC was less than 50 Bq/m^3 . This building was made from bricks and concrete in 1989, has no cellar and did not undergo any kind of thermal retrofit.
